**SRN6** hovercraft

**SR.N6 HOVERCRAFT  
COLD WEATHER TRIALS IN SWEDEN  
17TH FEBRUARY TO 26TH MARCH, 1966.**

Publication SP.1294      April 1966

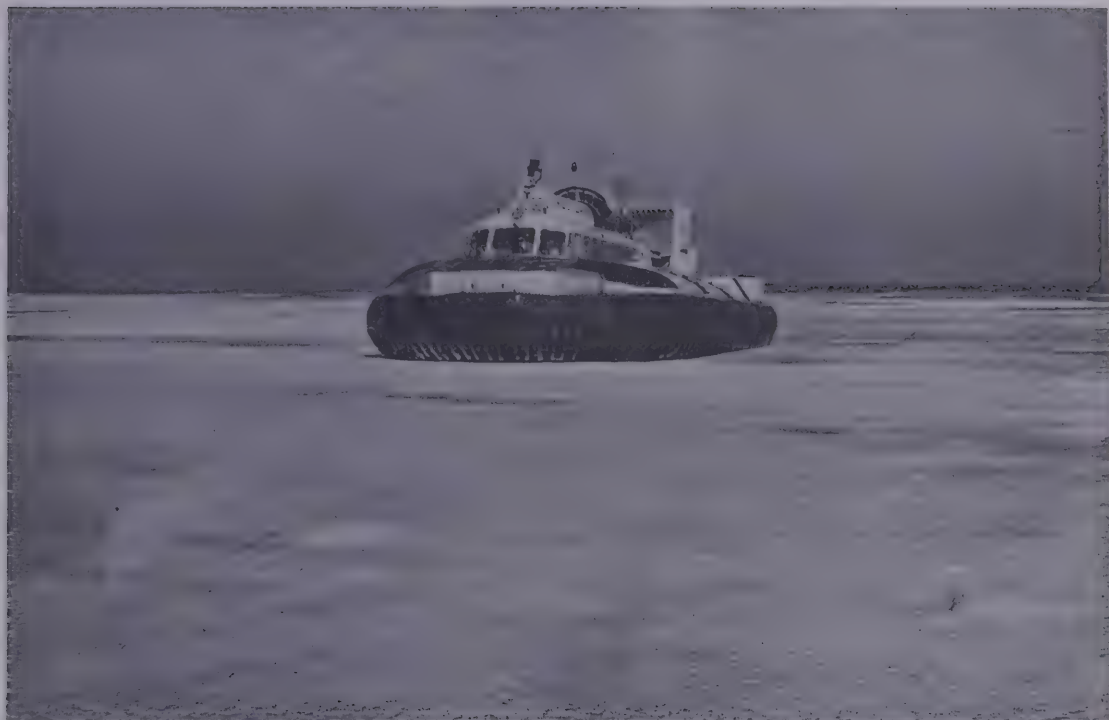
In high wind conditions it was quite satisfactory to run downwind at very low trpm, making good use of skirt friction. The interesting point was that this type of operation appeared to have no serious effects on skirt wear. Figure 3 shows the craft operating over typical smooth ice and fig.4 shows the track of a run over snow-covered smooth ice at low trpm. Stopping distances were not measured accurately over a speed range, but were enormously increased as compared with over-water distances; a half pirouette after reducing speed to about 20 knots, was the normal stopping technique.

**Fig. 3 OPERATING OVER SMOOTH ICE**

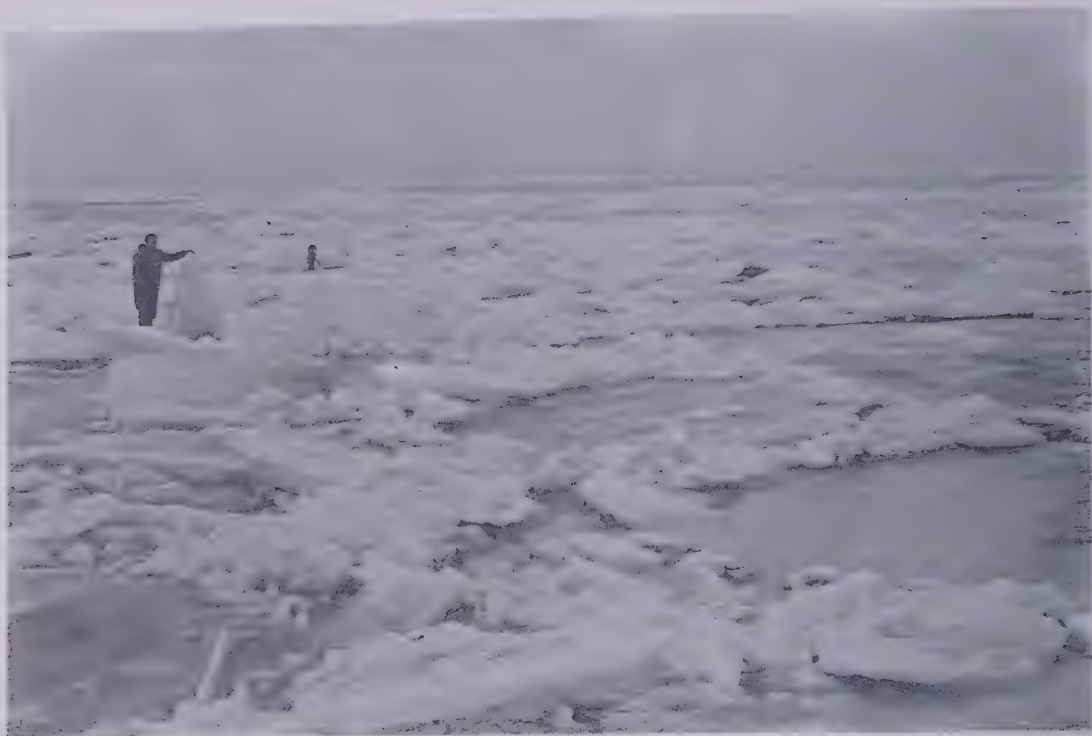
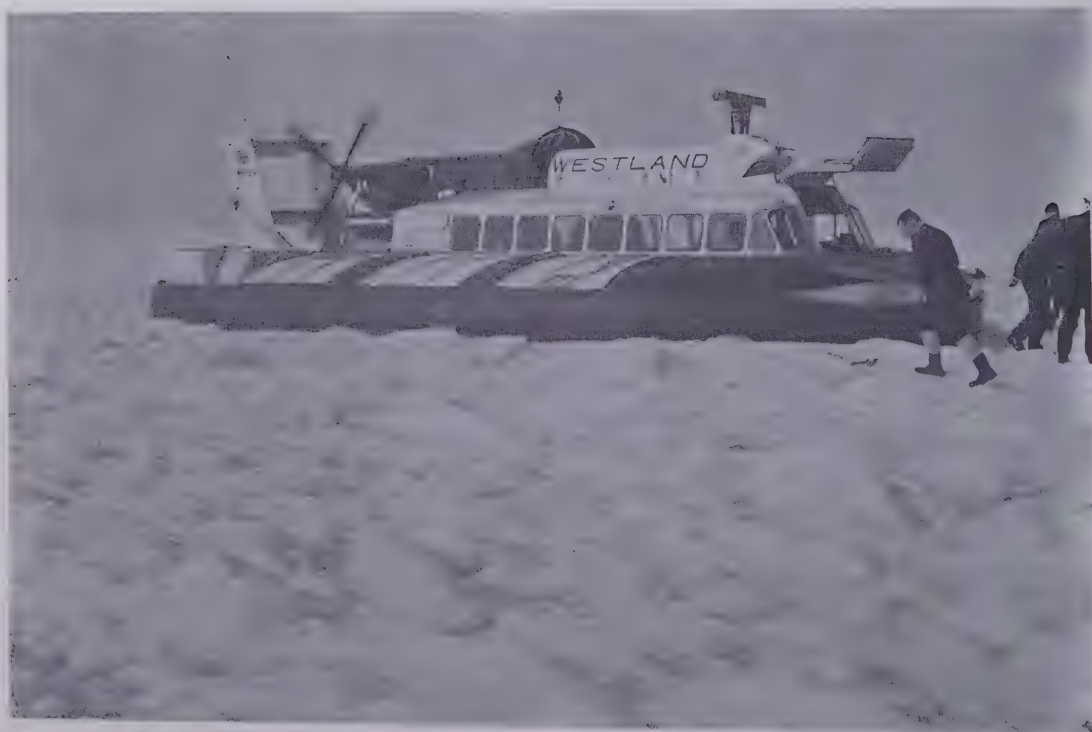
this rough ice. A typical ice field of the type found around Malmo is shown in fig. 5 and 6.

Fig. 5 & 6 TYPICAL ROUGH ICE IN THE MALMO AREA

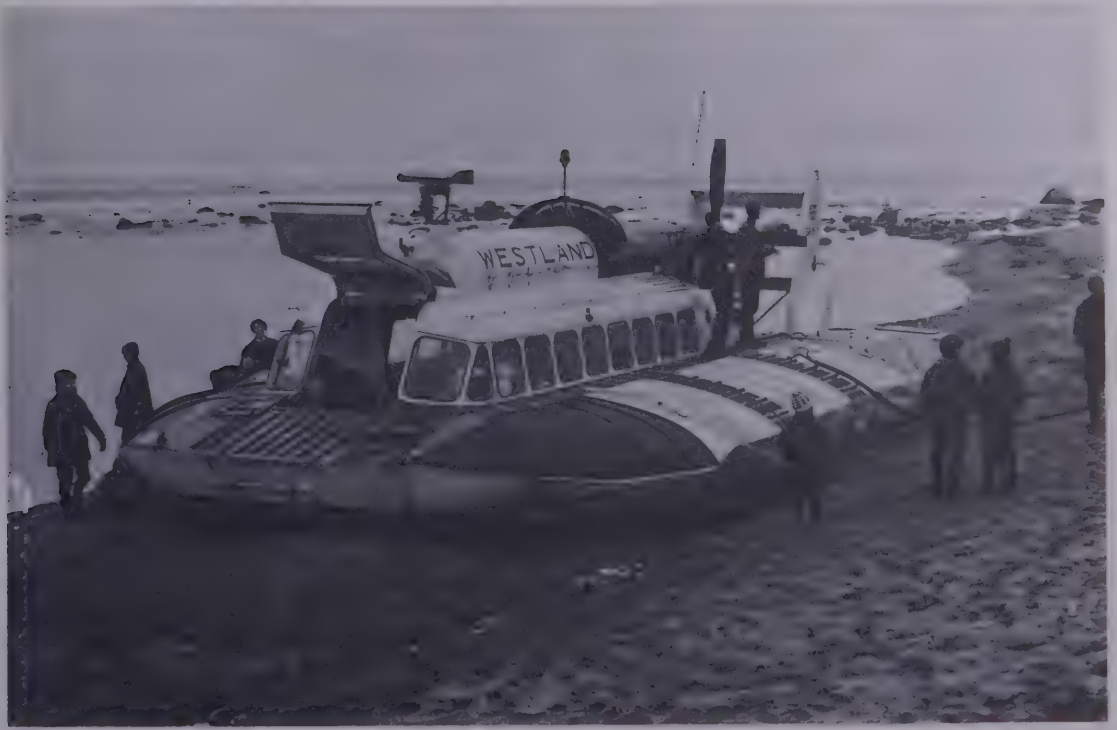
(c) Harbour at Simrishamn; very rough ice and no landing place. Went to beach outside harbour, approach being over huge boulders of piled-up broken ice. The 'parking' site for the night is shown in fig.8.

**Fig. 8 OVERNIGHT STOP AT SIMRISHAMN**

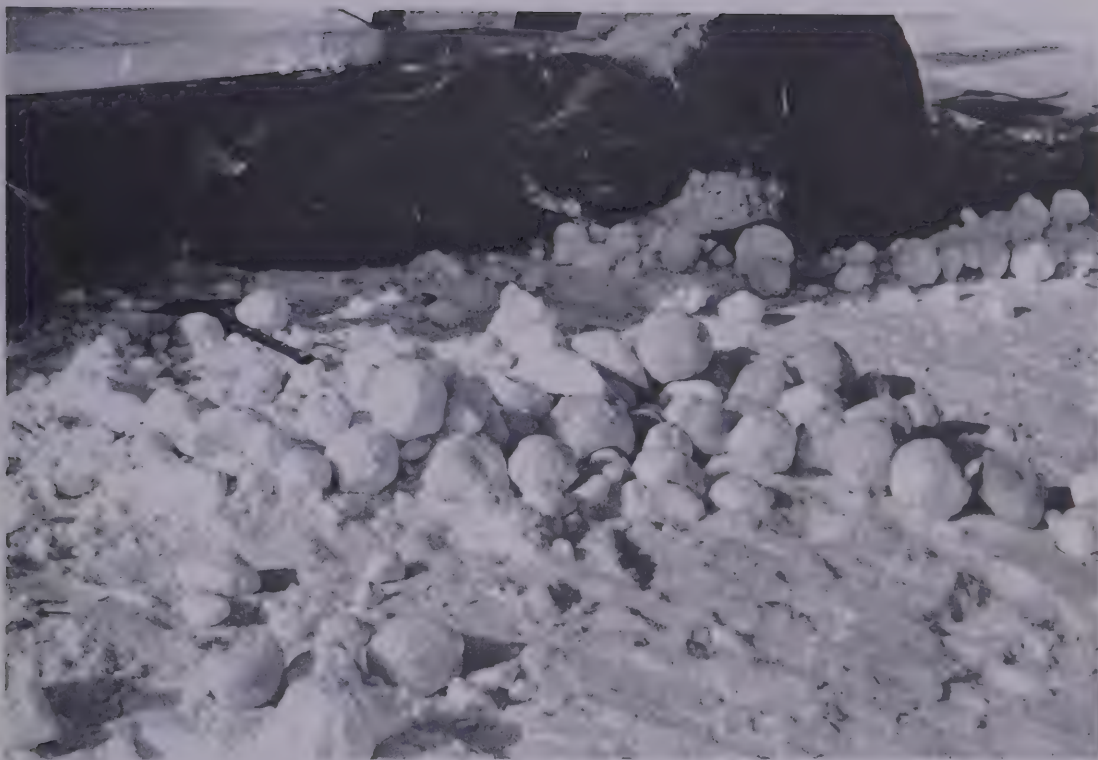
possibility of the skirts collecting large quantities of snow at the aft end. On the three occasions when this happened, snow and air temperature conditions were almost similar, and the indications were that the phenomenon was associated with a very narrow temperature range, probably  $0^{\circ} \pm 2^{\circ}\text{C}$ . The jet-type rear skirt bags (as fitted in Denmark) were therefore fitted to /009 to investigate the problem more fully and, by blanking off the jet for part of the trials period, to determine whether the non-jet bag would overcome it.

One other case of snow in the rear bags appeared to be significantly different from those described above, but an analysis shows that it probably had a similar origin. On arrival at Gavle after approximately 6 hours operating it was noted that the aft bags were half full of large balls of snow, frozen to almost solid ice, see fig.15. The craft had left Saltsjobaden early in the morning, some snow falling, and the temperature  $0^{\circ}\text{C}$  to  $-2^{\circ}\text{C}$ . The temperature fell steadily all the way to Oregrund when it was  $-10^{\circ}\text{C}$  and to  $-14^{\circ}\text{C}$  at Gavle. It is therefore almost certain that the snow was collected during the first mile or two after leaving Saltsjobaden and was then constantly rolled around inside the skirt and frozen into the condition found at Gavle.

**Fig. 15 SNOWBALLS REMOVED FROM AFT SKIRTS**

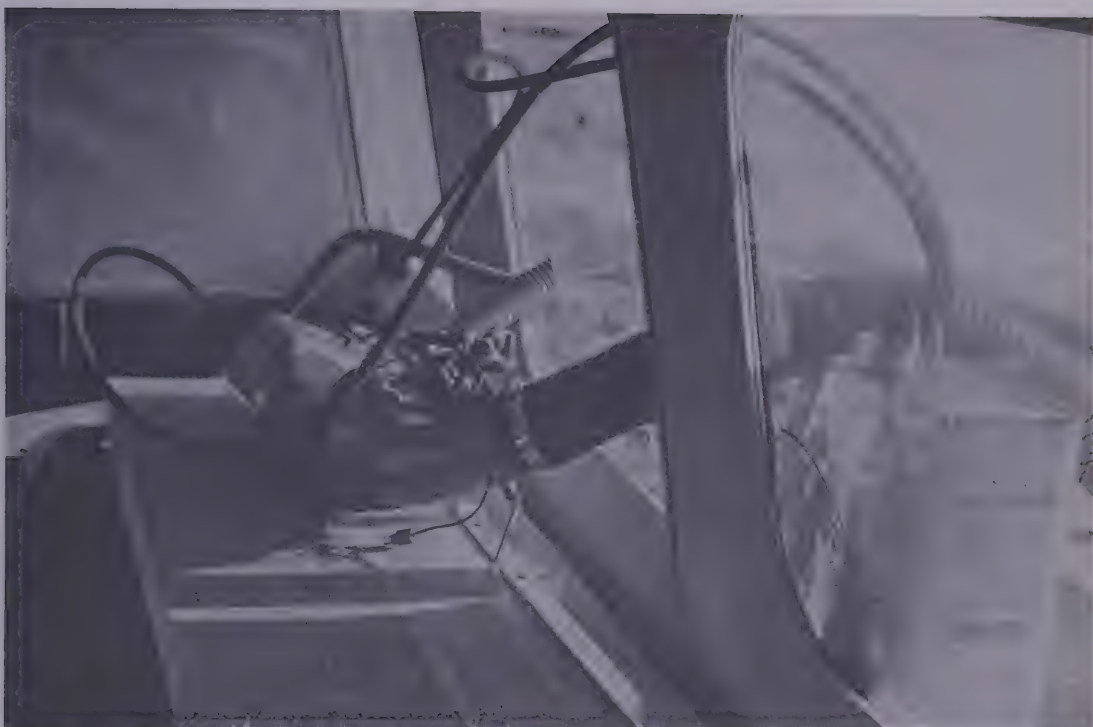
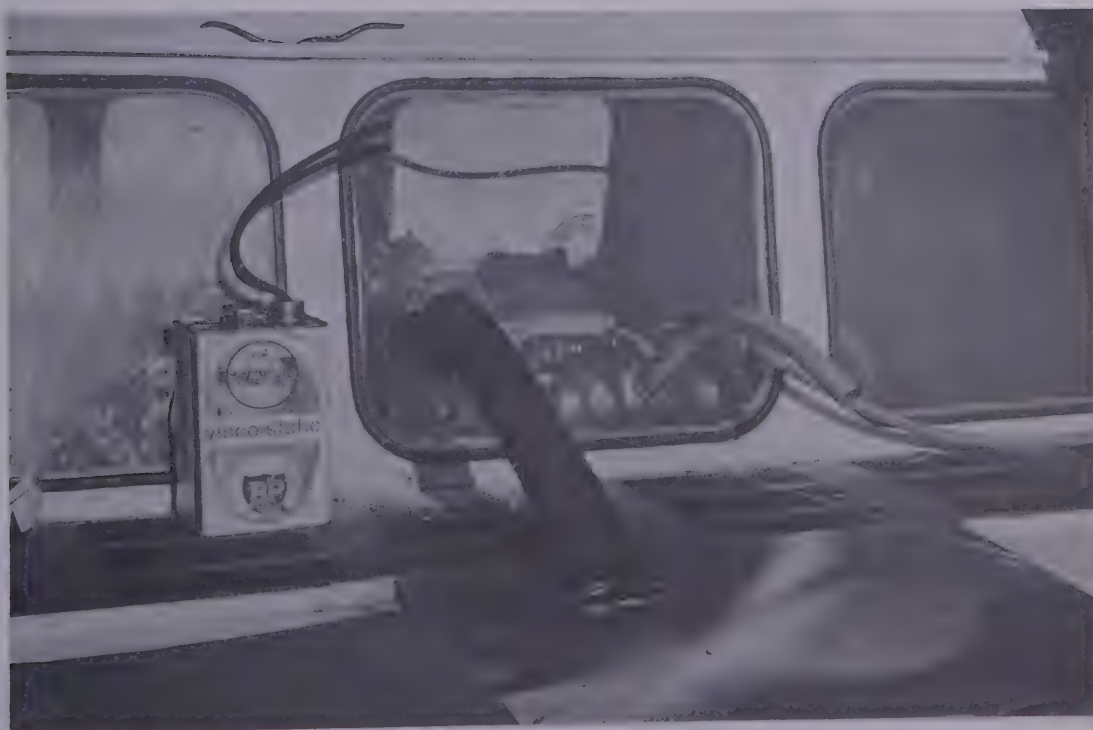
Fig. 18 & 19 COMBUSTION HEATER TRIAL INSTALLATION FOR SKIN DE-ICING

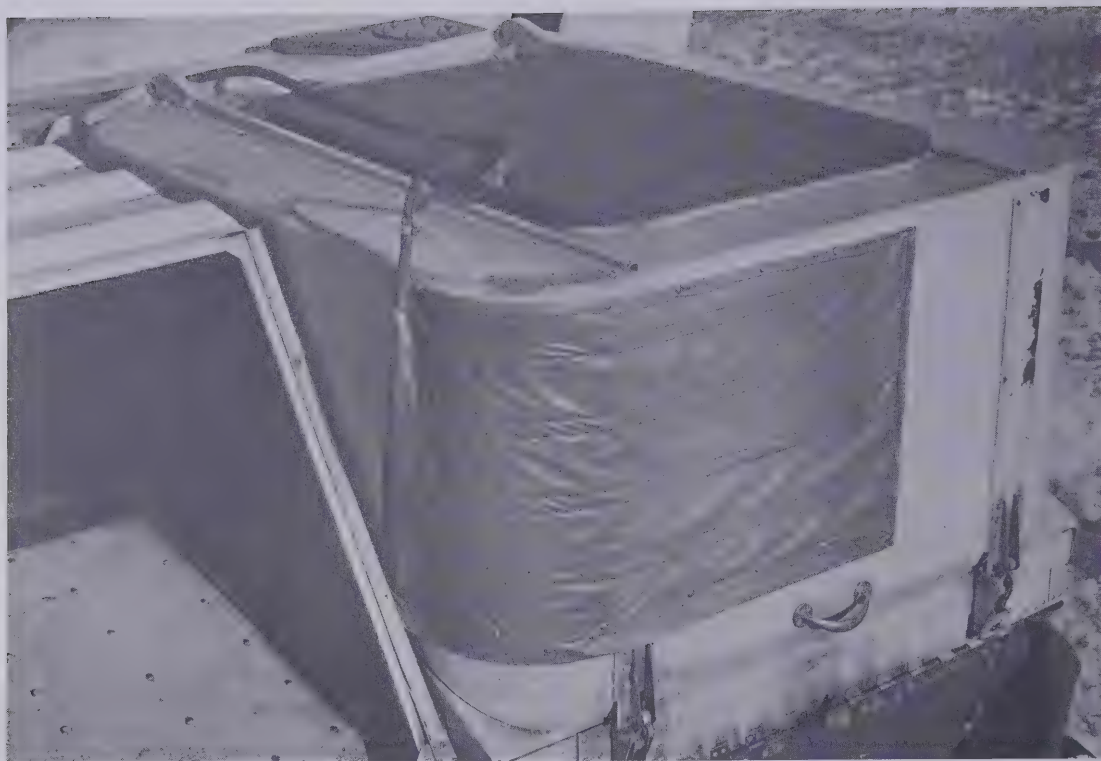
**Fig. 20 PNEUMATIC DE-ICING TRIAL INSTALLATION**

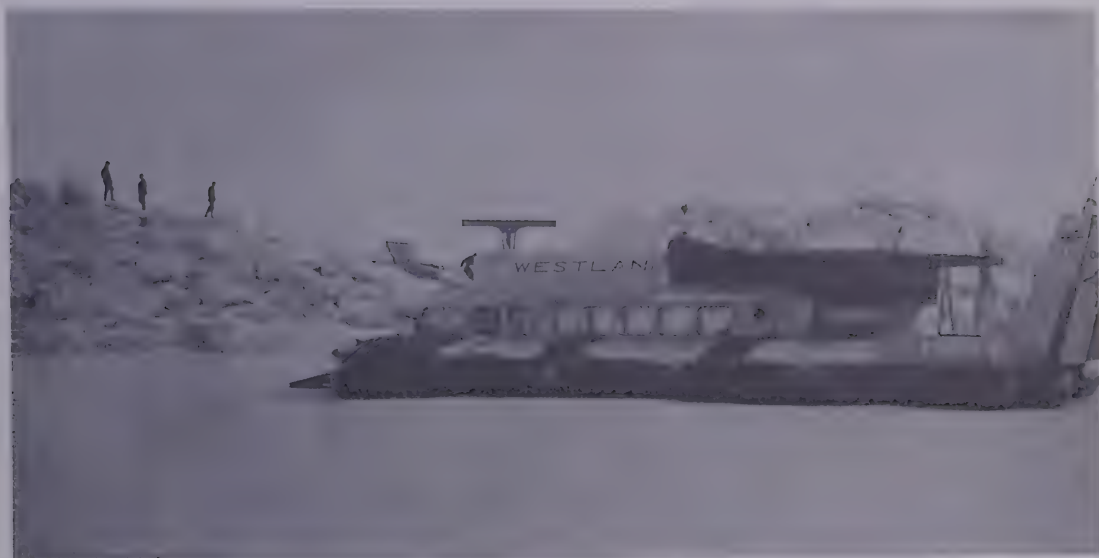
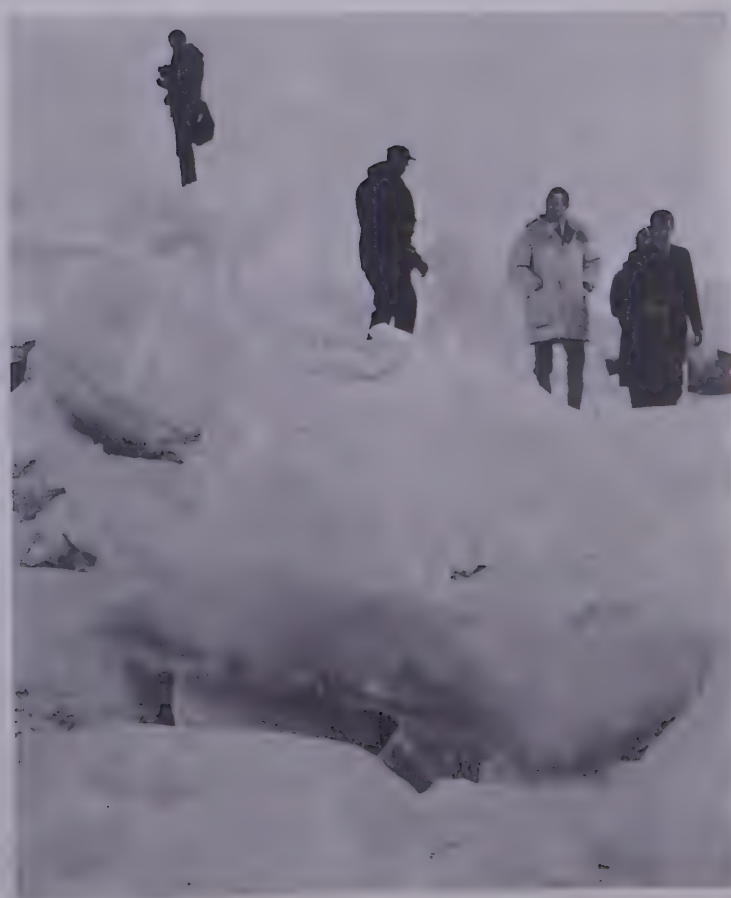
Weather conditions; Wind 10-15 kt. north-west, clear sky, good visibility, temperature just above 0°C. Photographs of ice hills off Soderhamn are given in fig. 21 and 22.

Fig. 21 & 22 A LARGE ICE HILL OFF SODERHAMN

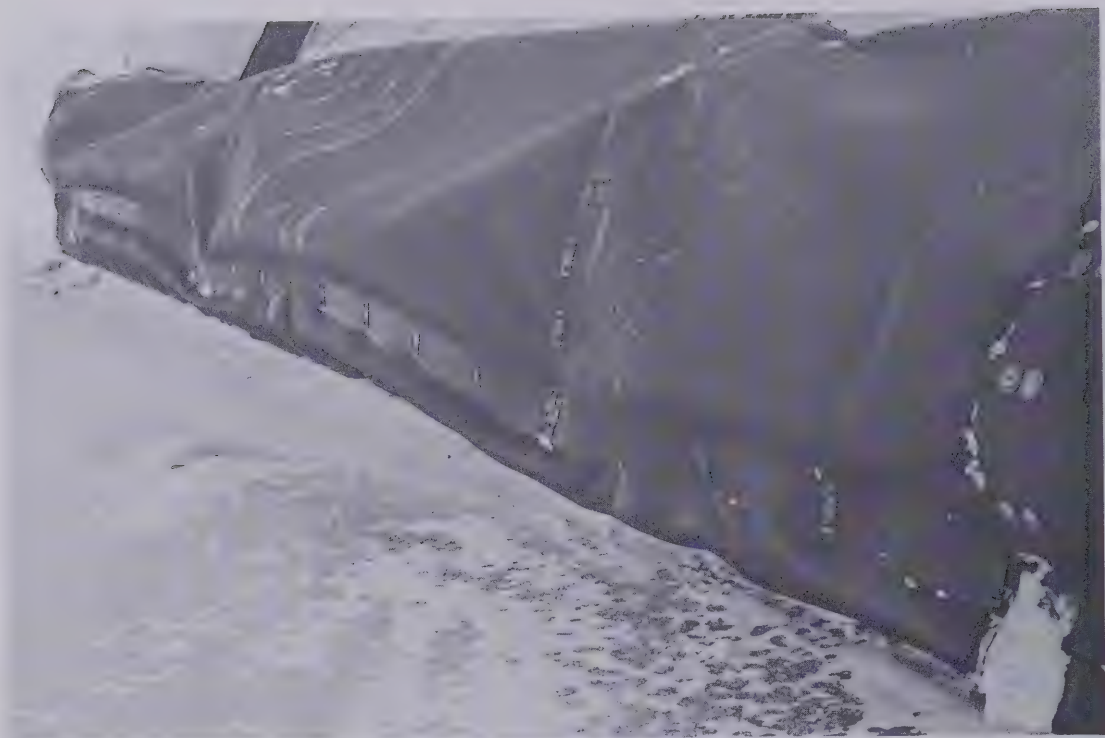
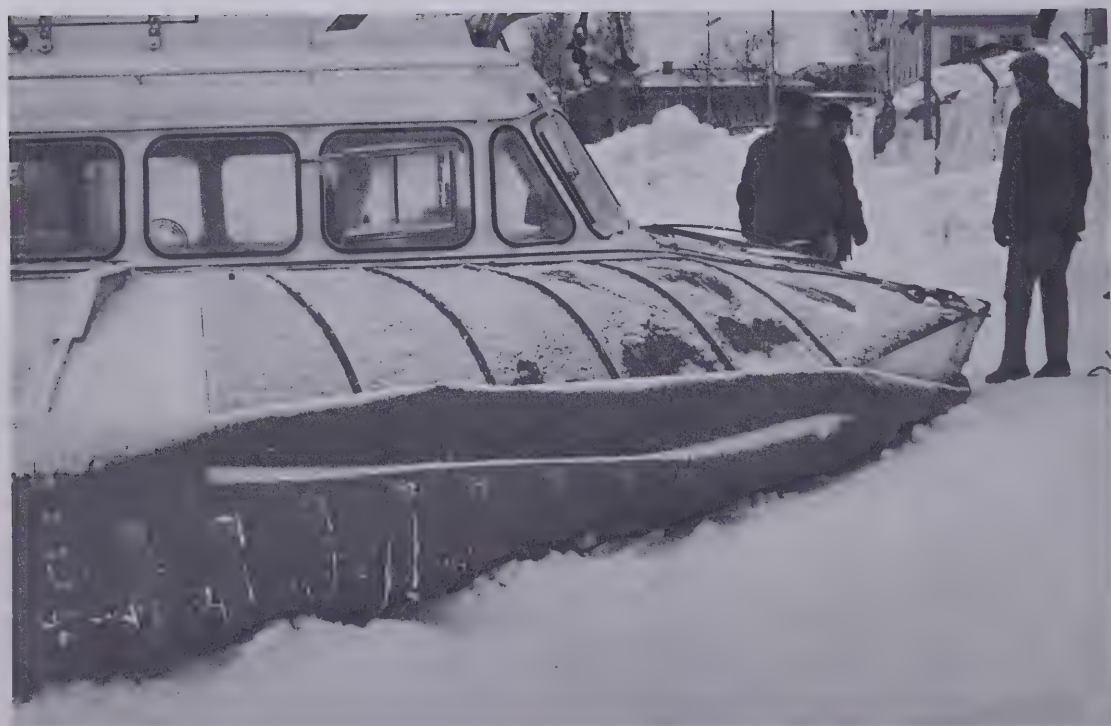
The hovercraft was normally left on the ice or snow at night and it was expected that the skirts would be 'frozen on' in the morning. This did not present any undue difficulty. The depth of 'freezing on' depended upon a number of factors such as the state of the ice when the craft was put on it, the amount of day sunshine or snow, and the degree of night frost. Ten or fifteen minutes spent with a trenching shovel freeing the skirt from the ice ensured that no serious sticking was still in force (other than the keel) when the engine was started and the skirts inflated. An ice axe to help free the skirts is also very useful, but it was found that having got an area of skirt free of the ice then it was relatively easy to work a way all round.

Fig. 23 & 24 FROZEN-IN SKIRTS
